# Perkins&Will

## Egleston Hall Summary of Findings

05.15.2026

## All Saints Egleston Hall and Parish House BUILDING ENCLOSURE DUE DILIGENCE REVIEW

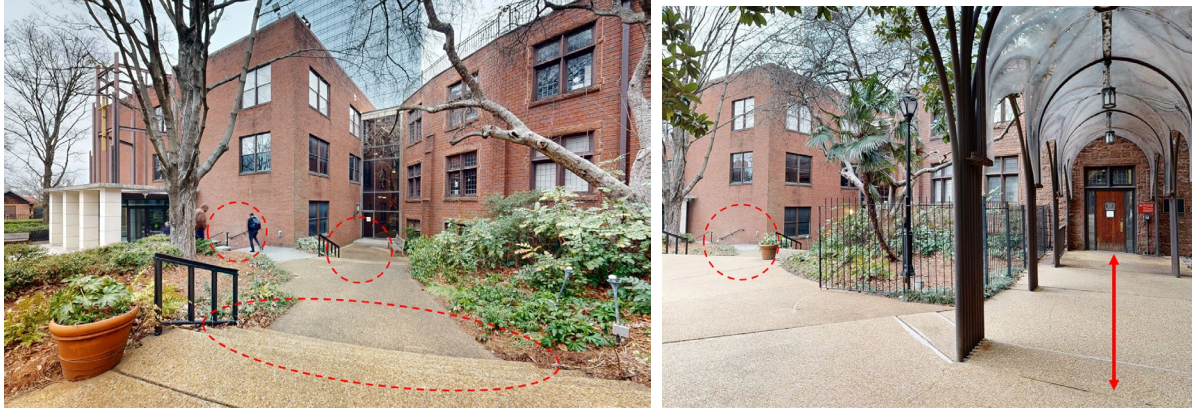
**FIGURE 3 EXTERIOR STAIRS LIMIT ACCESSIBILITY INTO EGGLESTON HALL FROM THE COURTYARD**

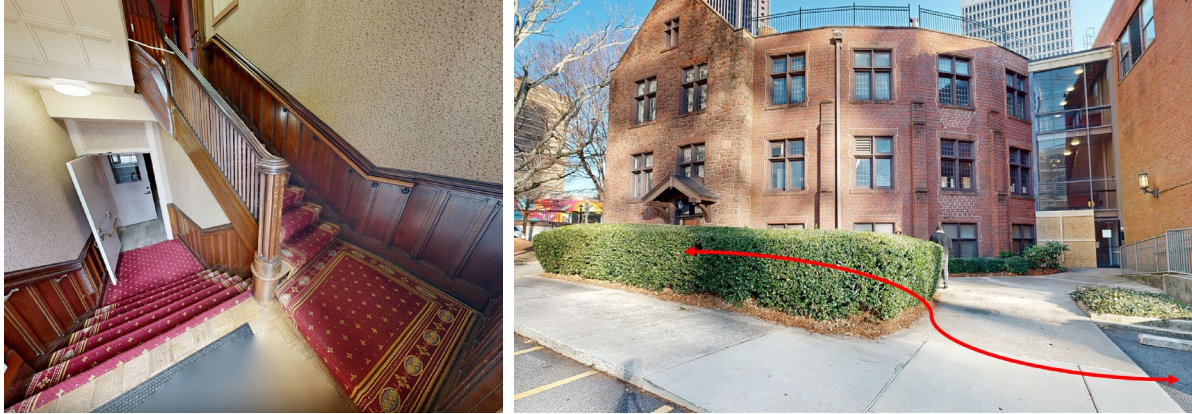
Egleston Hall presents significant accessibility limitations that affect all levels of the building. The primary level (Level 02) is elevated above grade on both the north and south sides, resulting in noncompliant accessible entry conditions. The south entry is approximately 2'-4" above grade, while the north entry is approximately 7'-7" above grade. Per the Americans with Disabilities Act (ADA) the north entrance to Egleston Hall has a compliant accessible route to the building from the ADA parking space there, but once in the building accessibility is immediately limited by stairs. Similarly, the south entrance is accessible from the public sidewalk but once inside the building accessibility is limited.

**FIGURE 5 THE ACCESSIBLE ROUTE FROM ADA PARKING IS BLOCKED BY STAIRS ONCE INSIDE THE BUILDING**

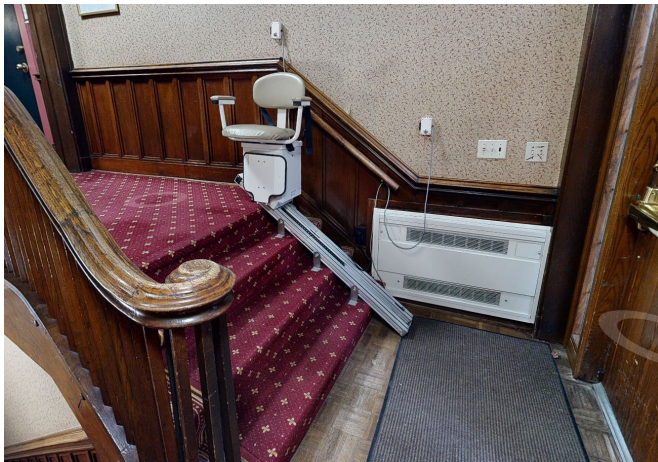
A stair chair lift (**Fig. 5**) has been installed at the south entry stair; however, stair lifts do not meet ADA requirements and are generally not considered acceptable solutions for public or commercial buildings. There are no elevators or ramps within the Egleston Hall footprint, rendering all levels of the building inaccessible from an ADA standpoint.

**FIGURE 6 EXISTING STAIR CHAIR LIFT IS NOT COMPLIANT WITH ADA REQUIREMENTS**

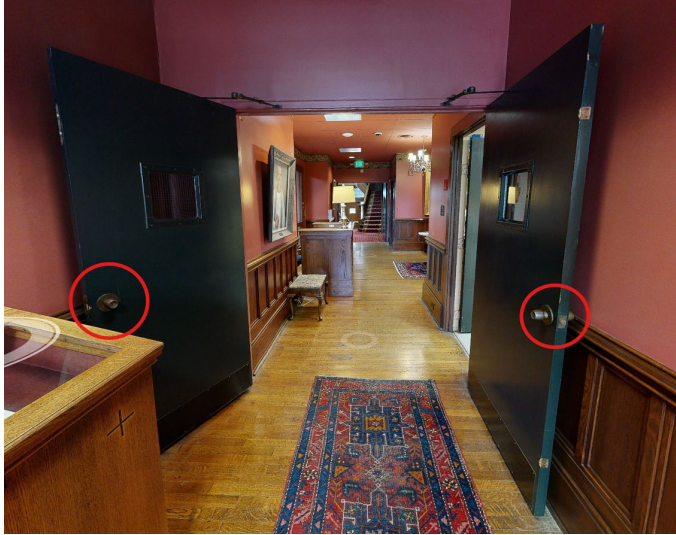
Deficiencies were identified related to door hardware along the egress path, particularly at doors serving the connection stair. Several required egress doors at Levels 02 and 03 are equipped with knob hardware, which does not comply with ADA standards stated in chapter §309.4 Operable Parts (See **Fig. 7**). Additionally, doors in stair wells were propped open with no mechanism to close in the event of a fire (as required by code to protect the stair well).

**FIGURE 7 EXIT DOOR HARDWARE IS NOT COMPLIANT AND DOOR IS PROPPED OPEN**

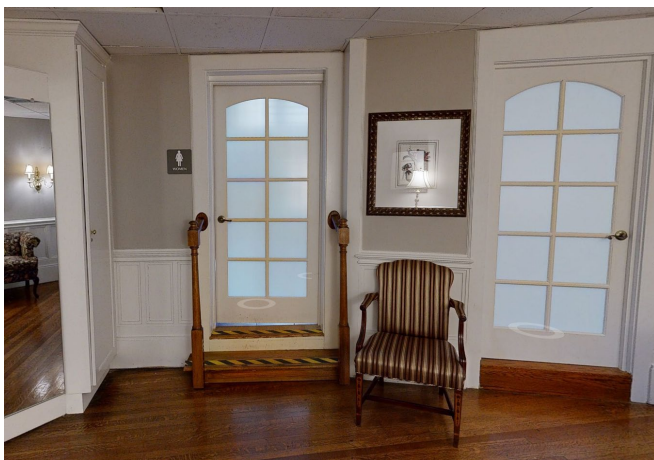
The existing conditions at nearly all restrooms, as well as the bride's room, require a step at the entry, creating an immediate barrier to accessibility. In addition to lacking required accessible features, such as grab bars and under-sink pipe protection, the more significant concern is that the spaces do not provide the minimum clearances necessary for maneuverability or proper access to plumbing fixtures. Addressing both the change in elevation and the required accessibility clearances would necessitate substantial spatial modifications, which would be challenging given the current constraints of the existing floor plan.

**FIGURE 8 RESTROOMS AND BRIDE'S ROOM ARE NOT ACCESSIBLE DUE TO STEPS**

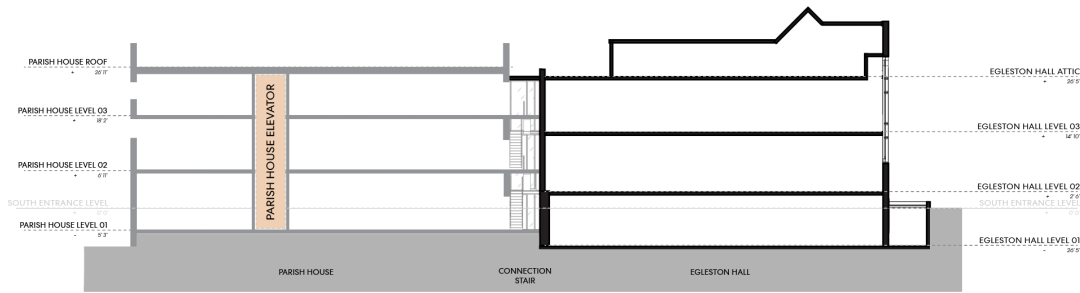
**FIGURE 9 SECTION THROUGH PARISH HOUSE AND EGGLESTON HALL SHOWING FLOOR LEVEL CHANGES**

The most straightforward solution for some of the items mentioned herein would be the installation of a new elevator to provide barrier-free access to each floor level. However, existing site constraints—including subterranean spaces, the multiple floor levels distributed across the Egleston Building and Parish Hall, and varying elevations within individual levels—would make implementation complex and costly. Refer to **Fig. 9**

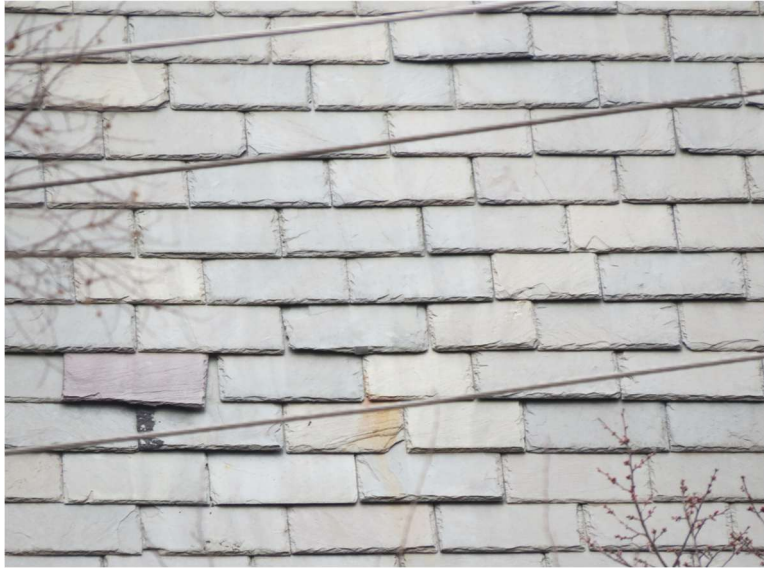
Photo 11: View of Egleston slate with displacement and broken edges.

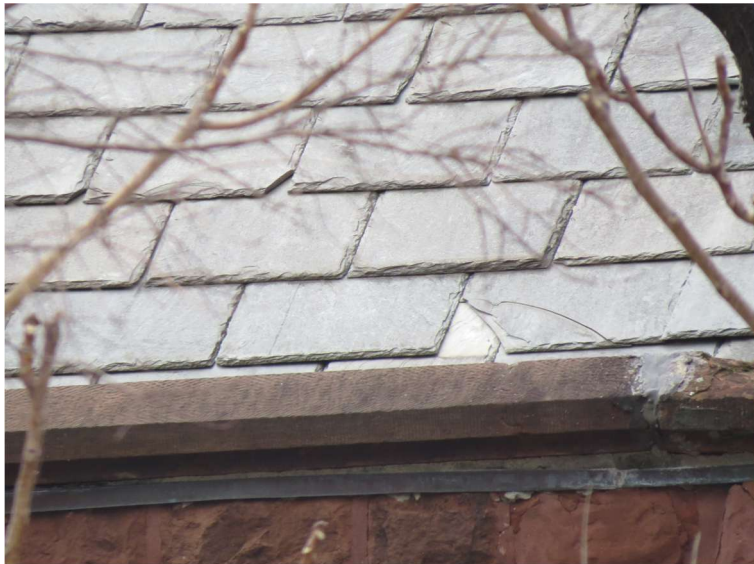
Photo 12: View of Egleston broken slate.

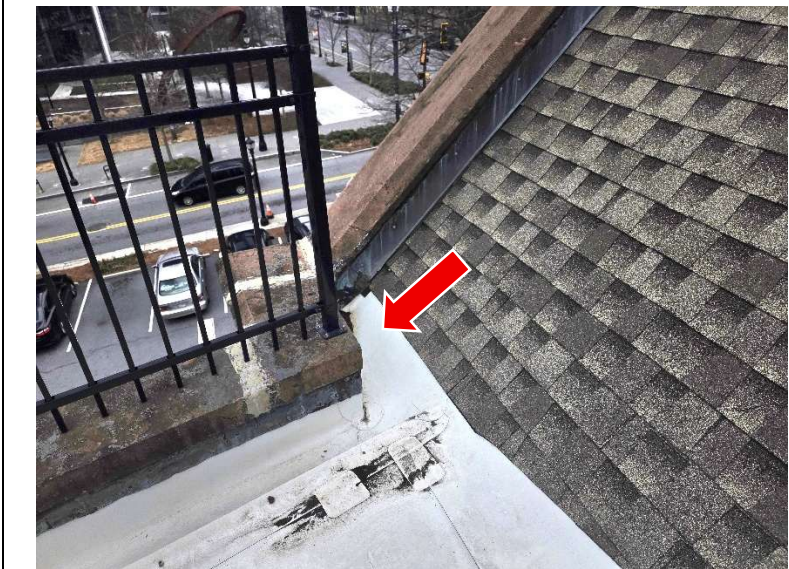
Photo 14: View of Egleston asphalt shingle roofing where it meets low slope TPO roofing; inside corner lacks diverter resulting in interior water damage.

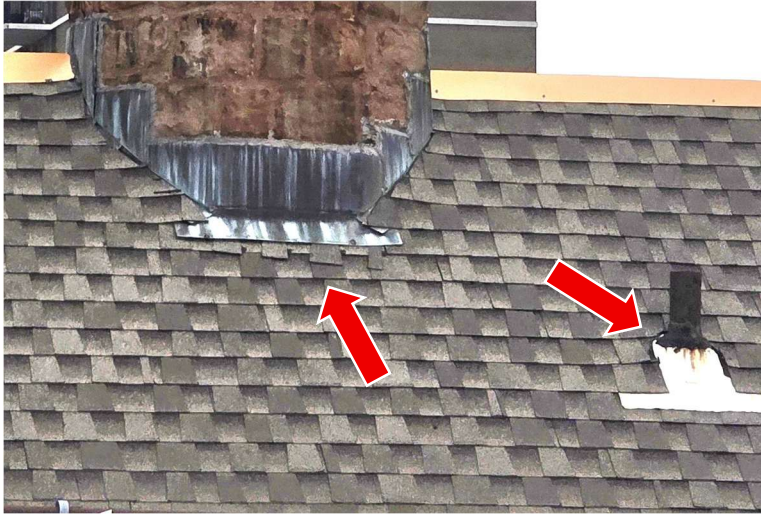
Photo 15: View of Egleston asphaltic shingles with displacement (left), corroded vent pipe (right).

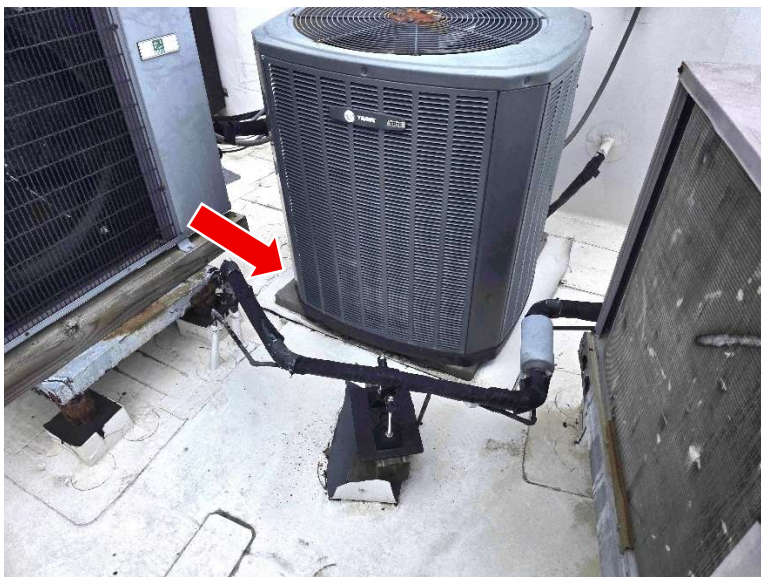
Photo 16: View of Egleston TPO roofing with mechanical unit lacking roofing curb.

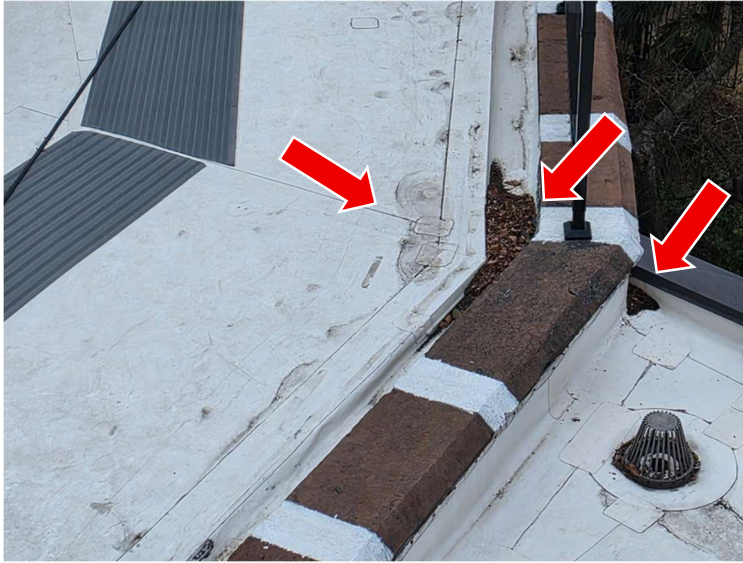
Photo 17: View of Egleston roof with debris accumulation at irregular conditions (right arrows) and membrane stains (left arrow) consistent with inadequate slope.

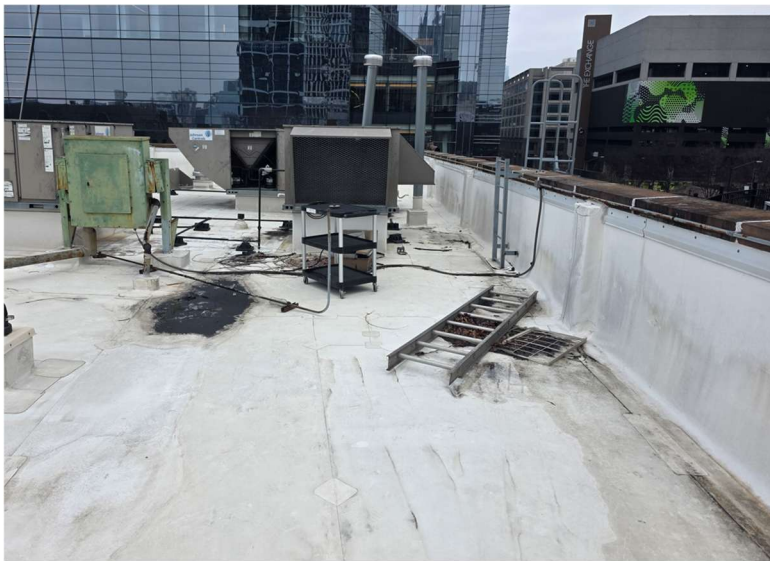
Photo 18: View of Parish House roof with debris accumulation, membrane staining consistent with inadequate drainage.

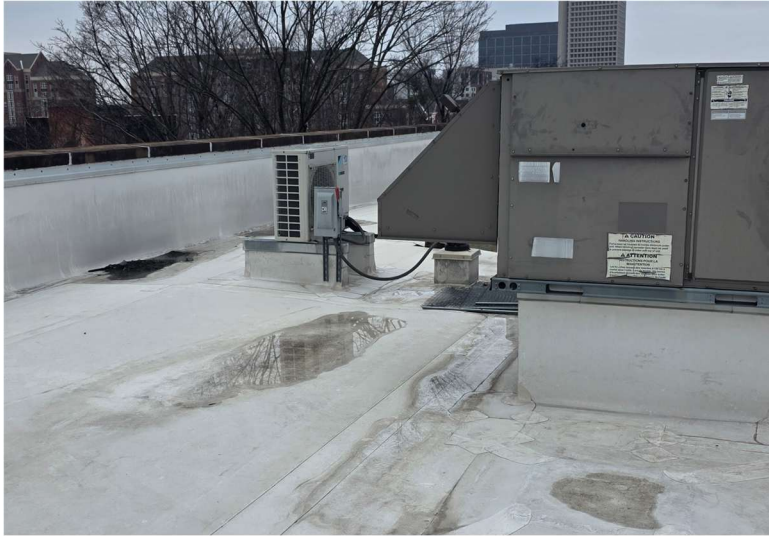
Photo 19: Parish Roof with standing water.

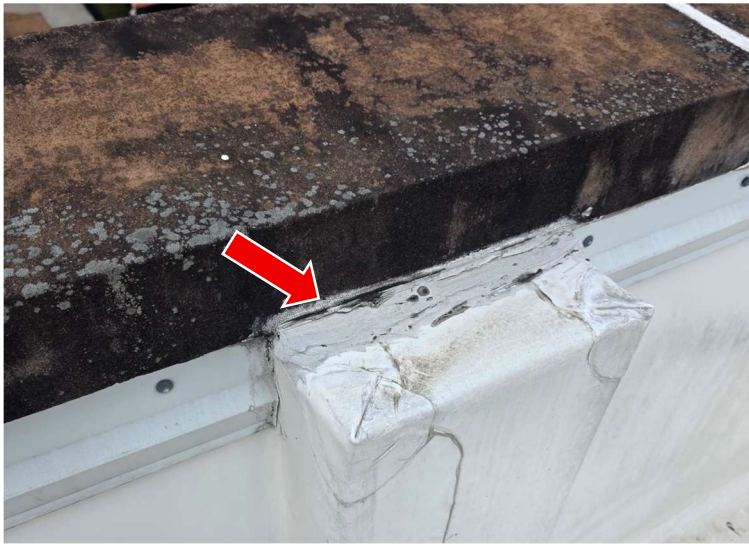
Photo 20: Parish Roof with gaps at sealant.

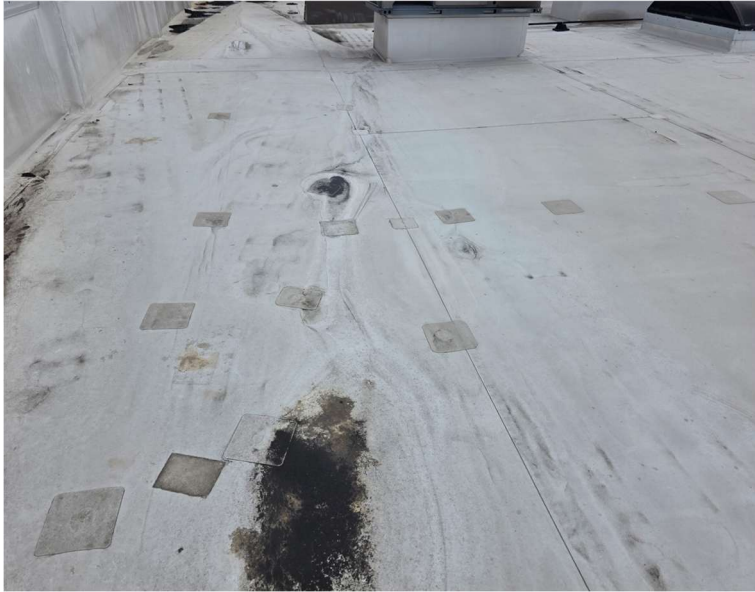
Photo 21: Parish roof with multiple membrane patches.

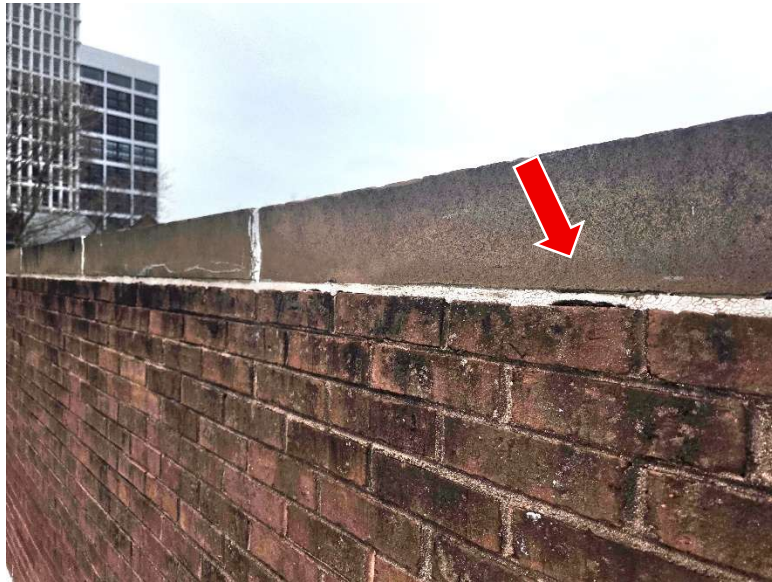
Photo 22: Parish parapet coping with open joint.

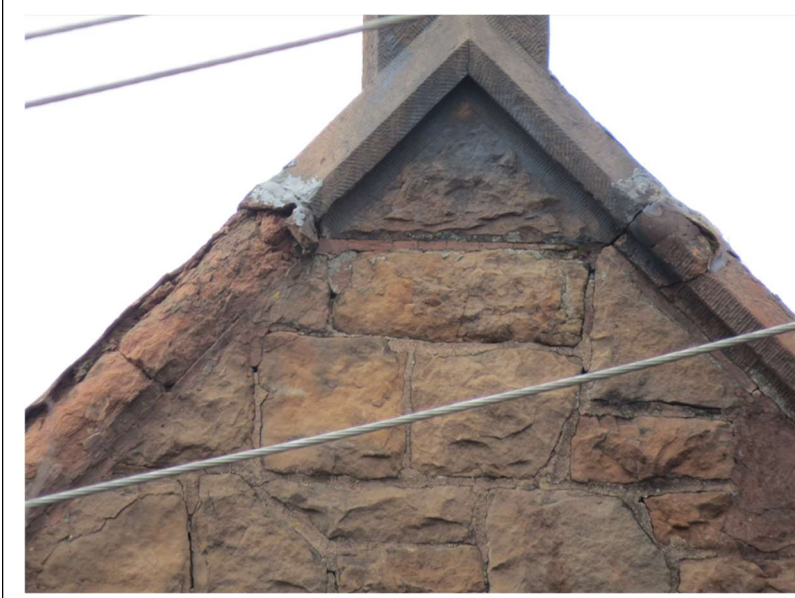
Photo 23: Egleston Hall gable with stone delamination and open stone joints.

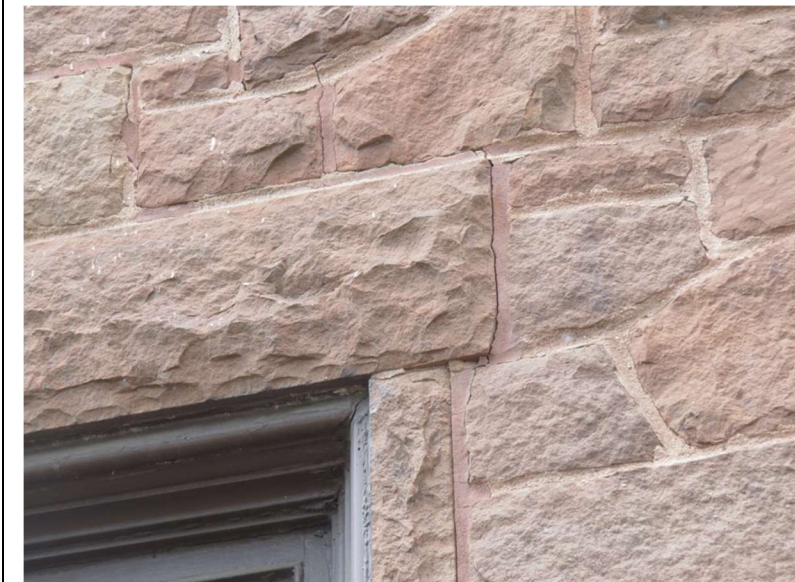
Photo 24: Egleston Hall with cracks or gaps at stone joints.

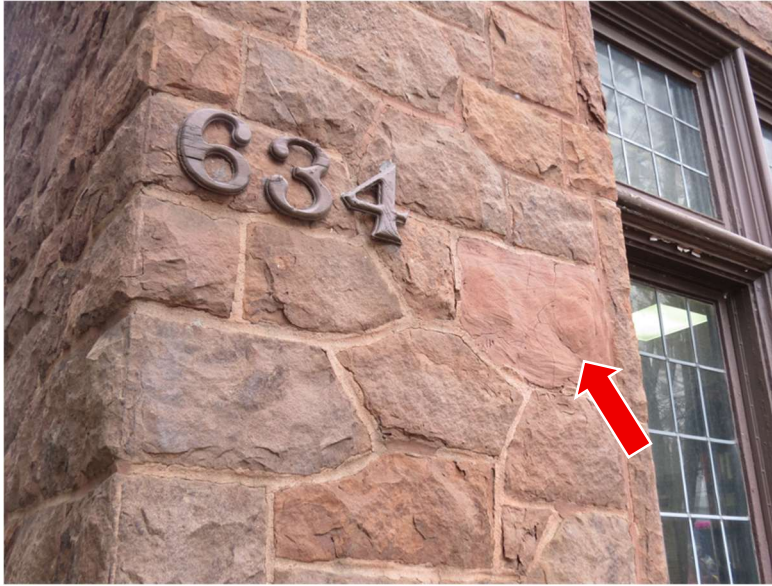
Photo 25: Egleston stone patch with cracks.

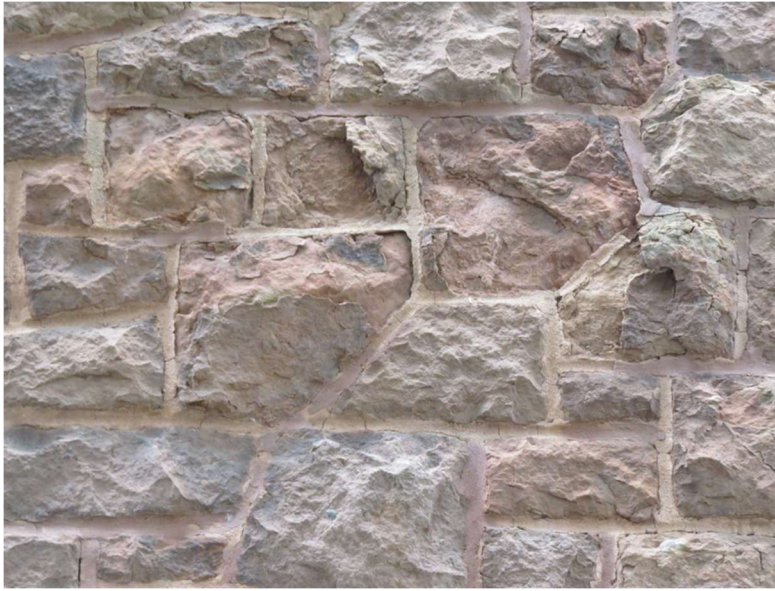
Photo 26: Egleston stone with face delamination.

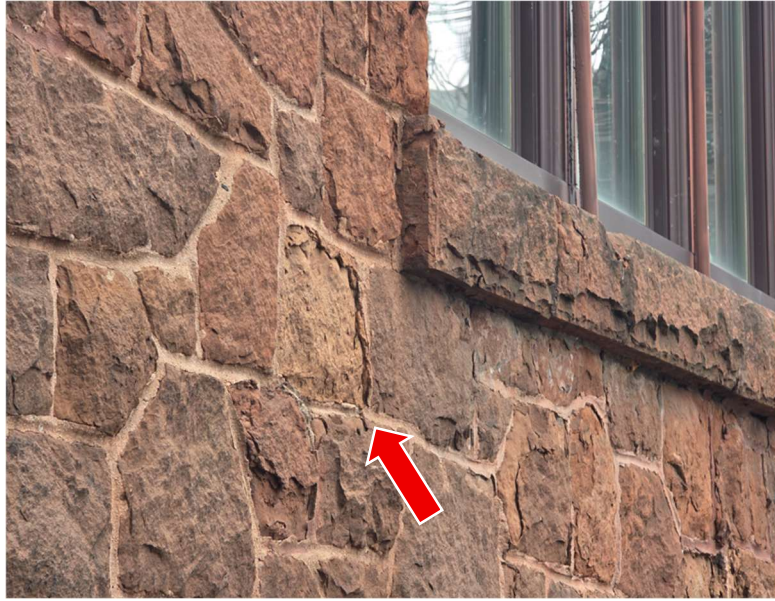
Photo 27: Egleston stone with face delamination.

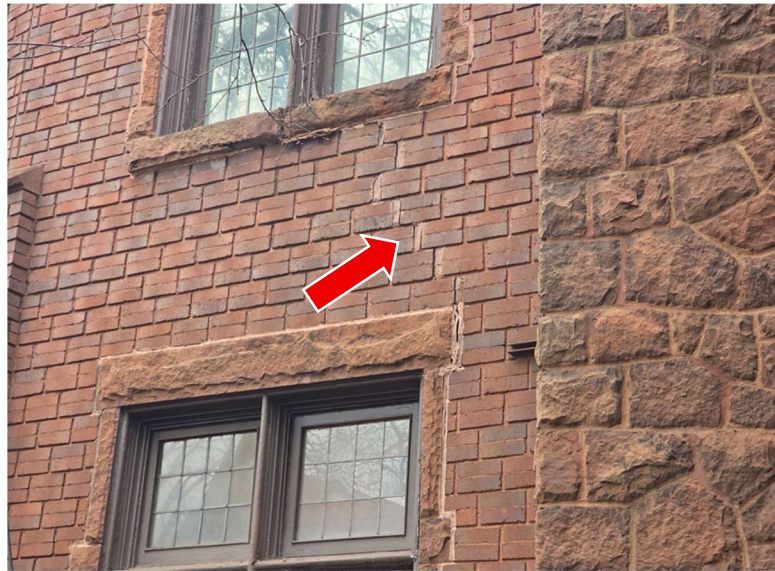
Photo 28: Egleston brick crack.

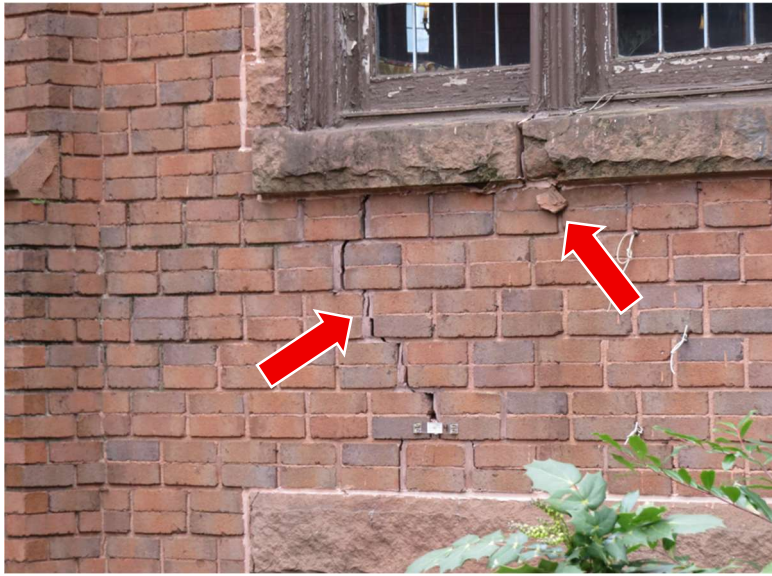
Photo 29: Egleston brick crack (left arrow). Also note stone sill spall hanging by sealant (right arrow).

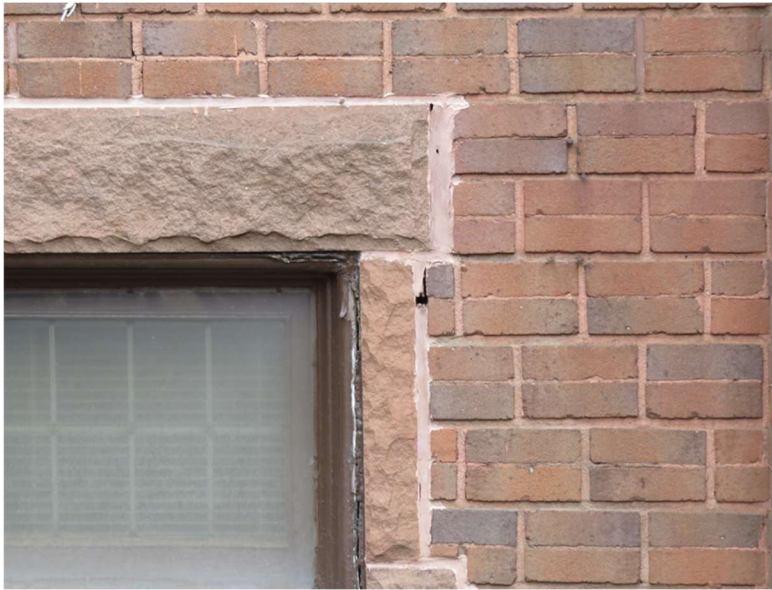
Photo 30: Egleston sealant repair at jamb stone quoins with joint gaps.

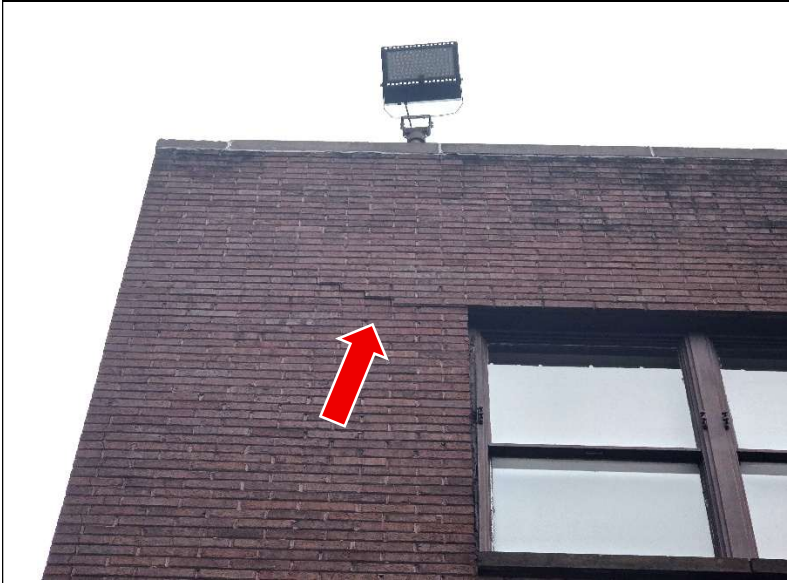
Photo 31: Parish Hall brick bulging.

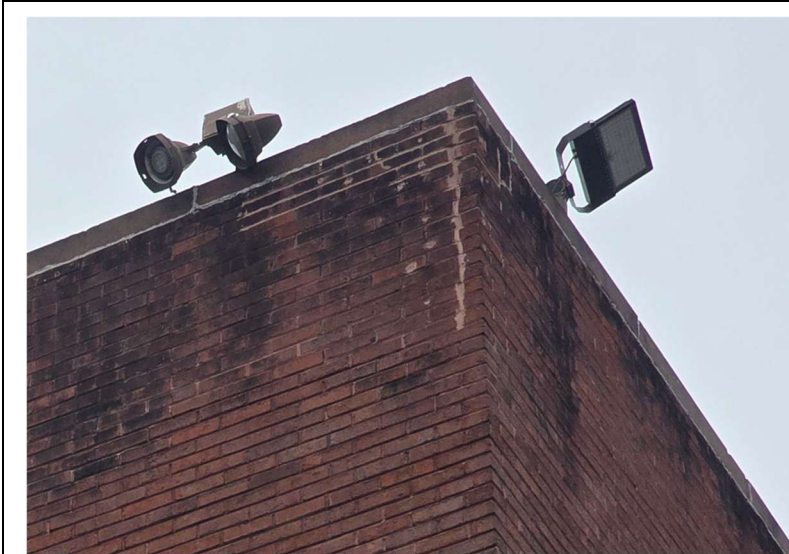
Photo 32: Parish Hall vertical brick crack and repair attempt at corner.

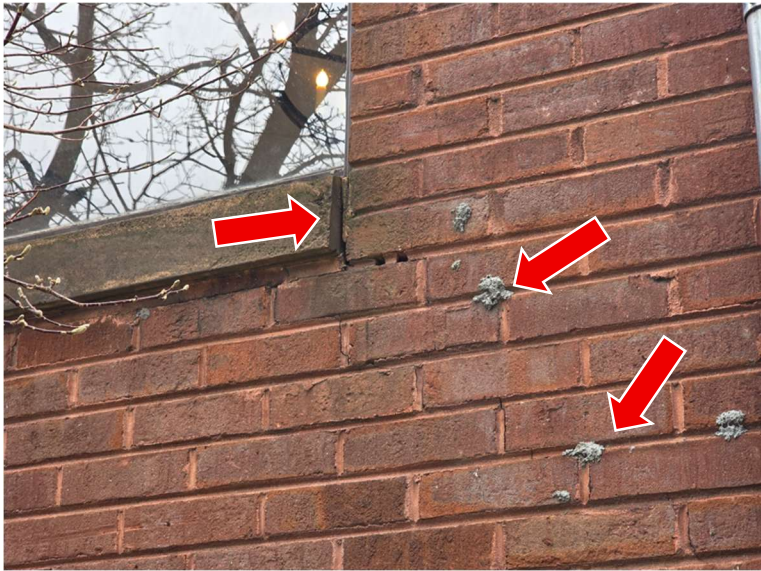
Photo 33: Parish Hall brick with joint gaps (left arrow) and likely remedial repair anchorage (right arrows).

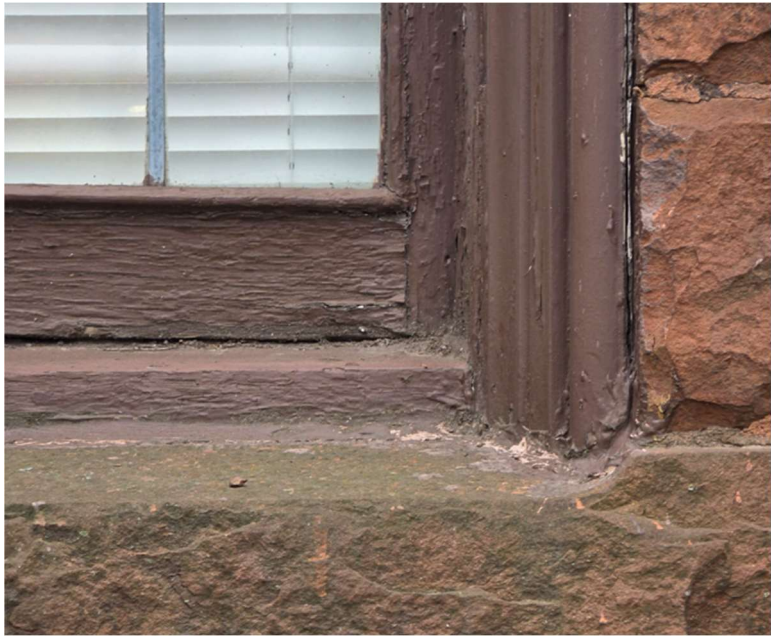
Photo 34: Egleston window frame decay and open joint at brickmold-stone joint.

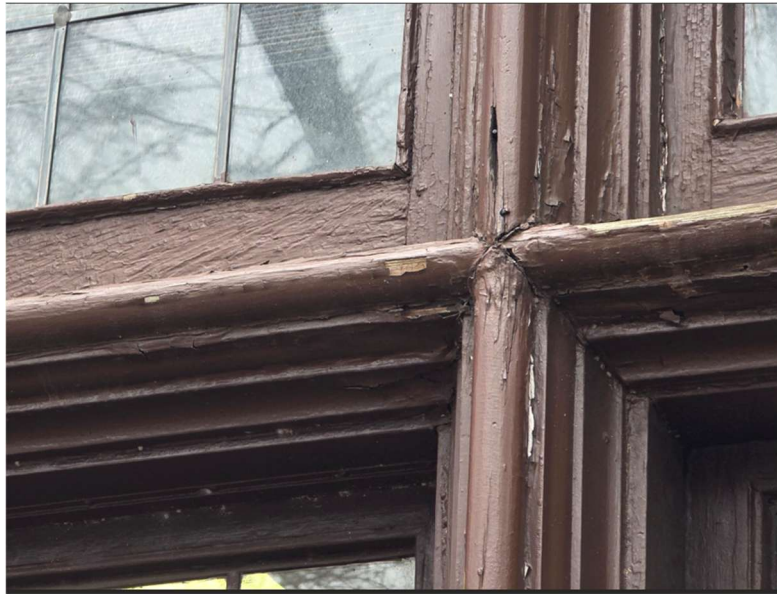
Photo 35: Egleston wood frame decay.

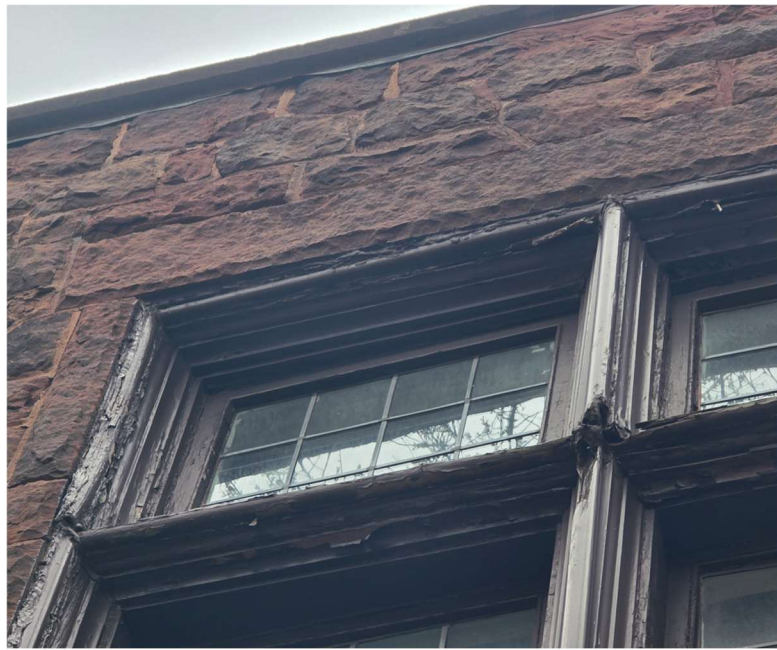
Photo 36: Egleston wood frame decay.

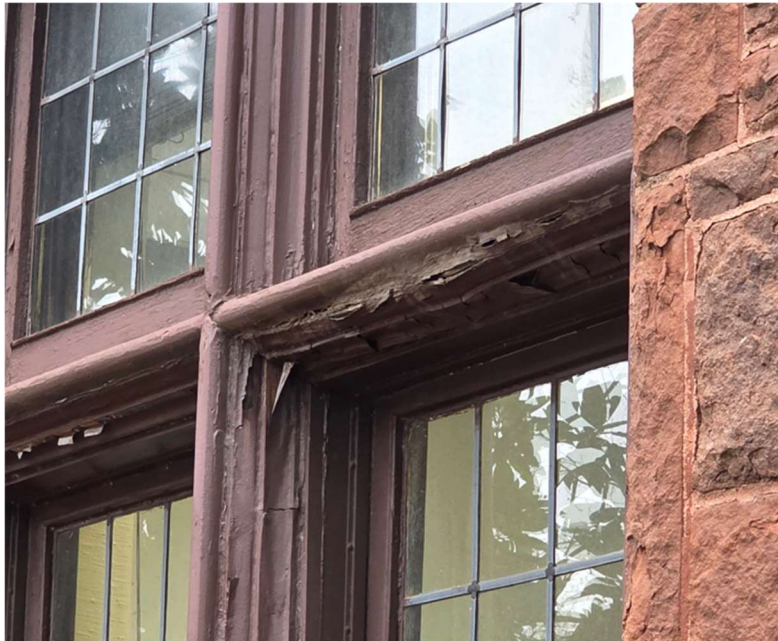
Photo 37: Egleston wood frame decay.

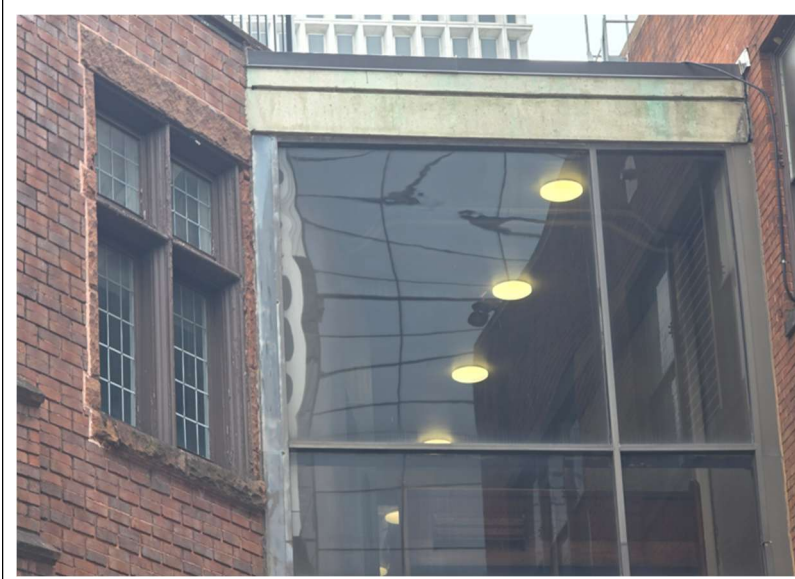
Photo 39: Egleston – Parish connector with deformed glass at curtain wall.

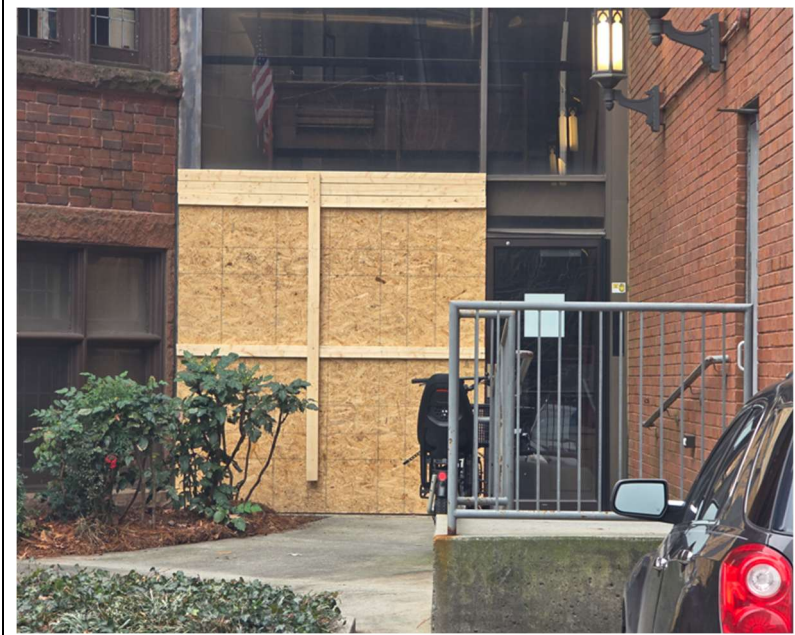
Photo 40: Egleston – Parish connector curtain wall with broken/missing section.

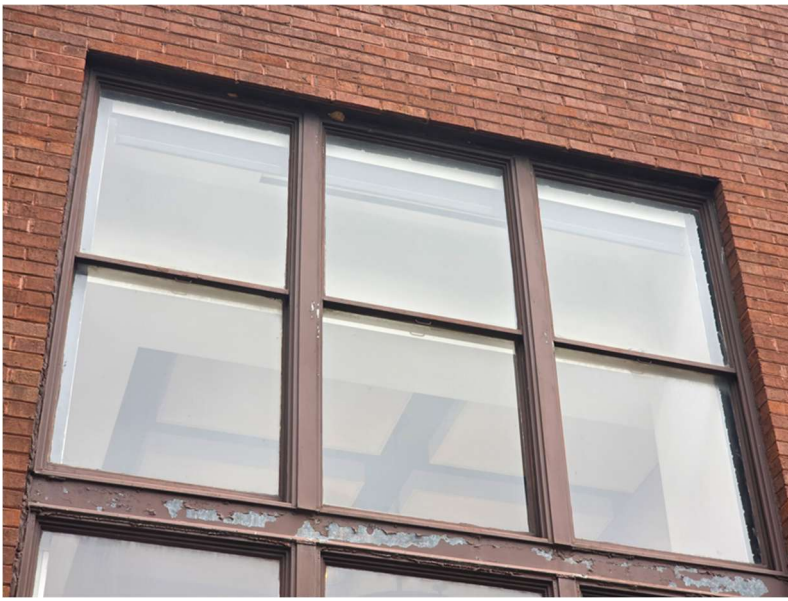
Photo 41: Parish Hall steel window with coating deterioration.

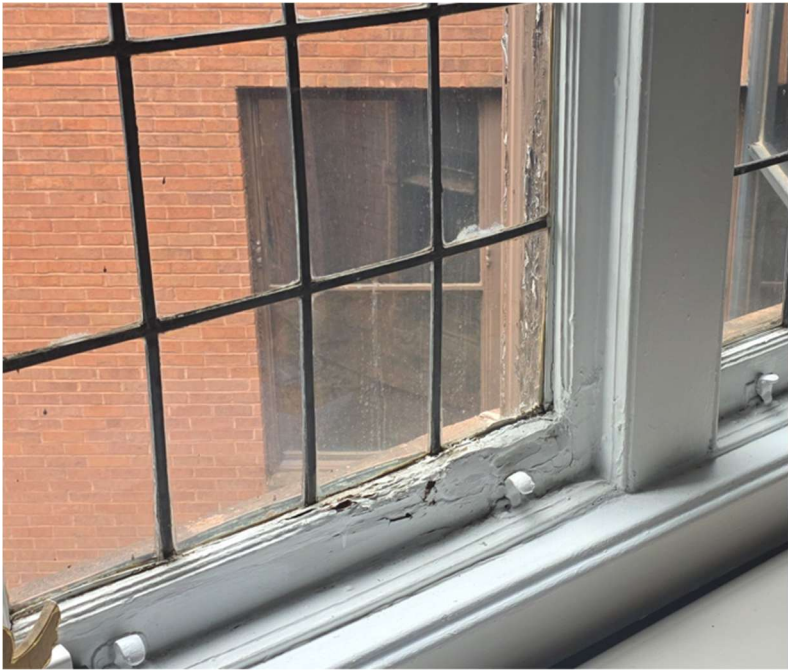
Photo 42: Egleston window sash decay with remedial repair attempts.

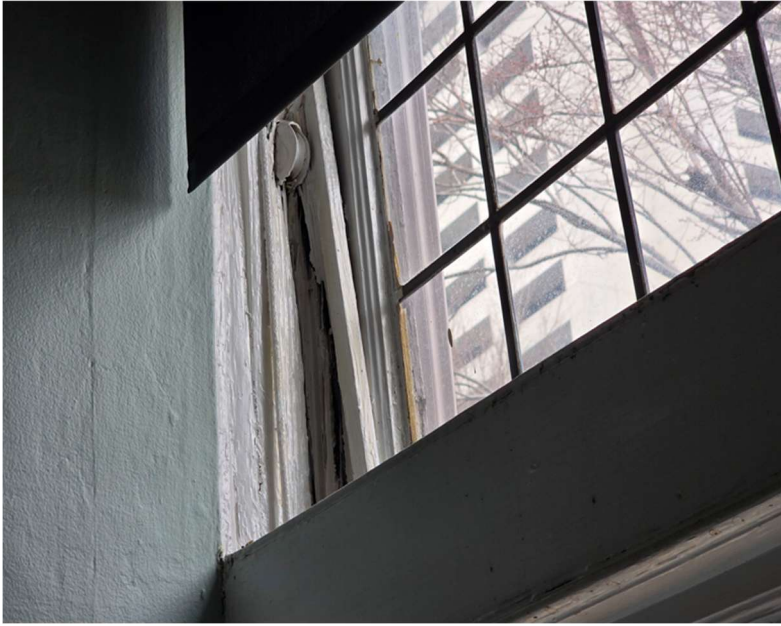
Photo 43: Egleston sash pulley disconnected and sash damage.

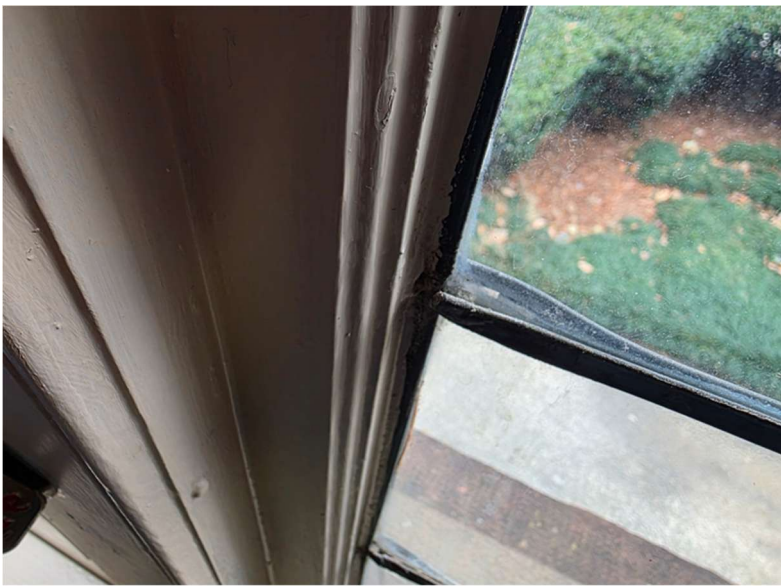
Photo 44: Egleston window lead came deformation.

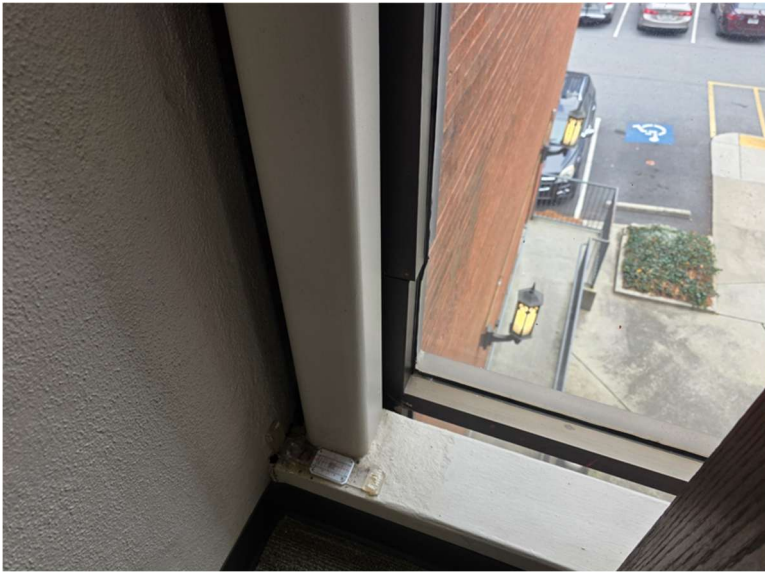
Photo 45: Egleston-Parish connector curtain wall with misaligned sections.

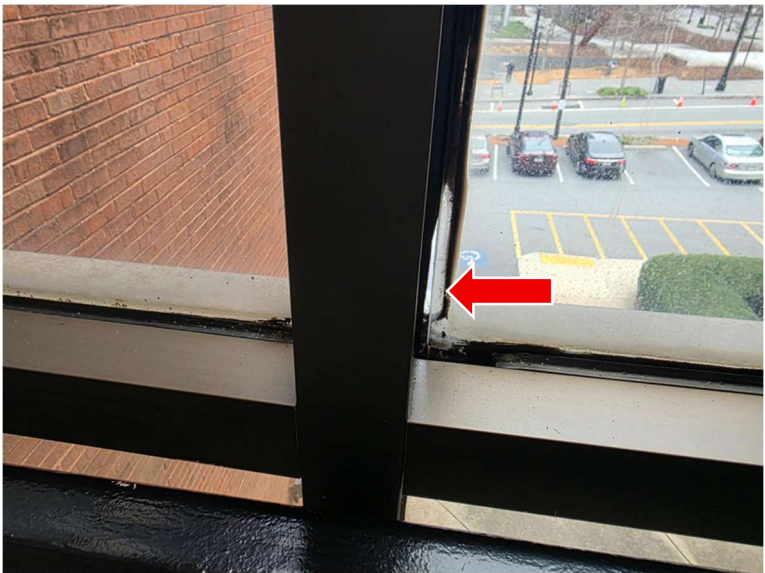
Photo 46: Egleston-Parish connector curtain wall with gap at glazing.

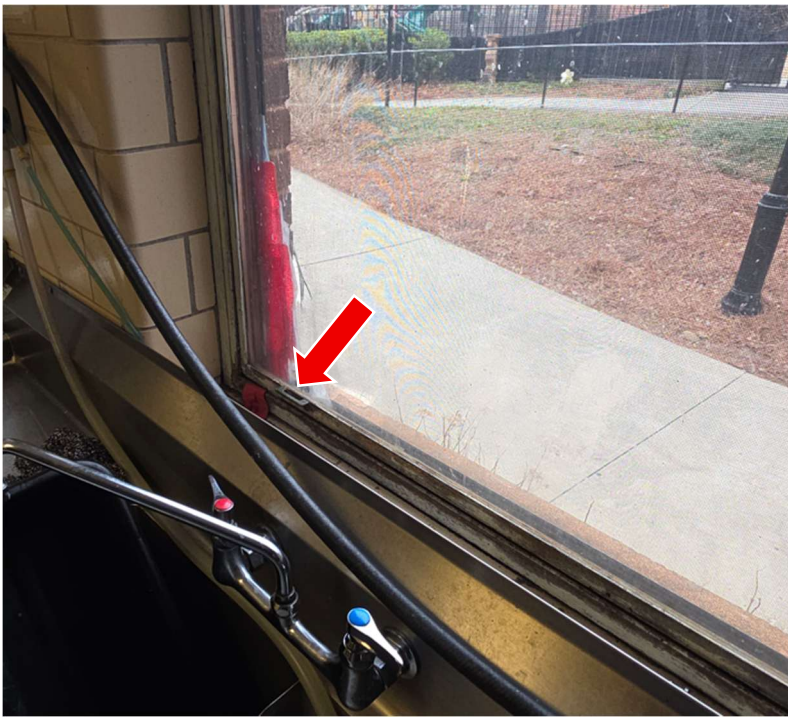
Photo 47: Parish Hall steel sash with gaps at glazing putty.

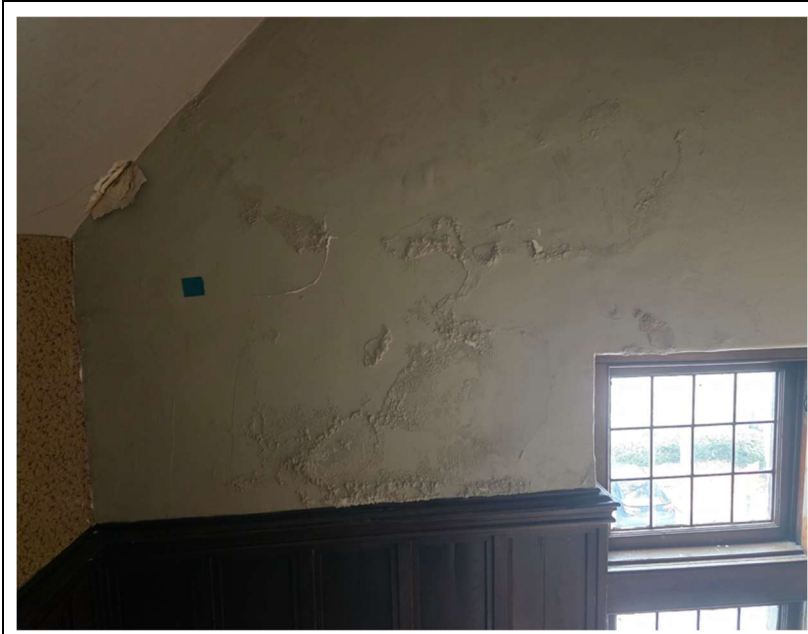
Photo 49: Egleston Hall with plaster damage at gable.
